CEMP Inspection

A site inspection was undertaken of the former Olive Morris House on Brixton Hill Road on **Friday 11 December 2020**, to establish compliance with the Construction Environmental Management Plan (CEMP)

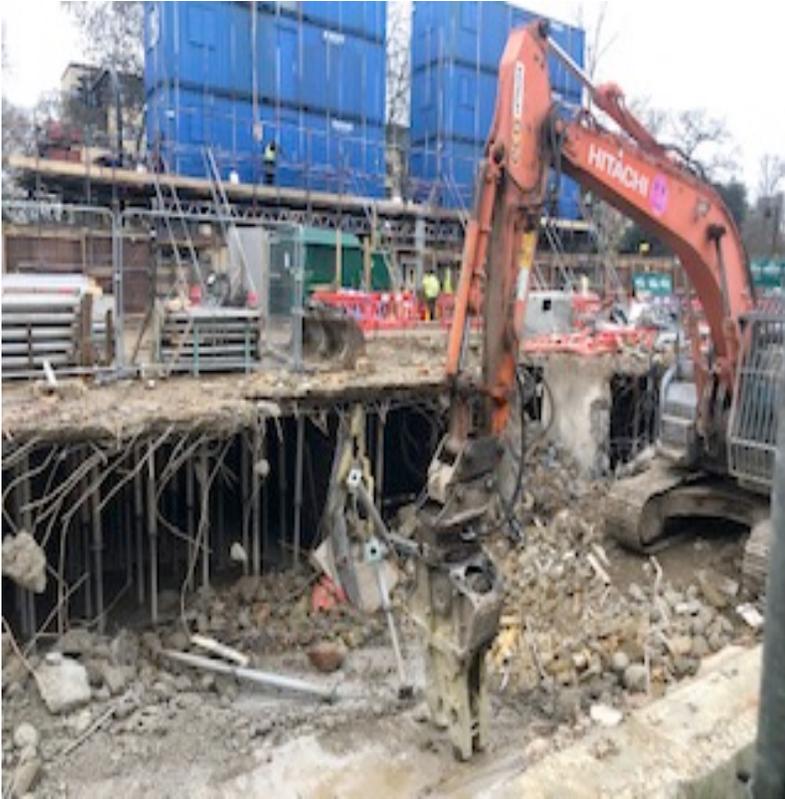
Ground Floor removal works

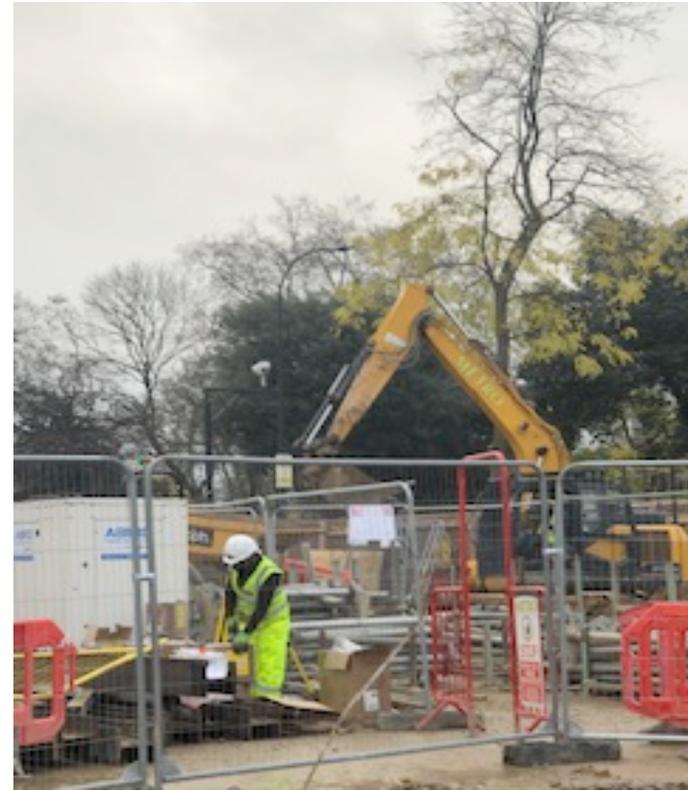
Excavator removing excess materials
