# CEMP Inspection

A site inspection was undertaken of the former Olive Morris House on Brixton Hill Road on **Friday 5 February 2021**, to establish compliance with the Construction Environmental Management Plan (CEMP)

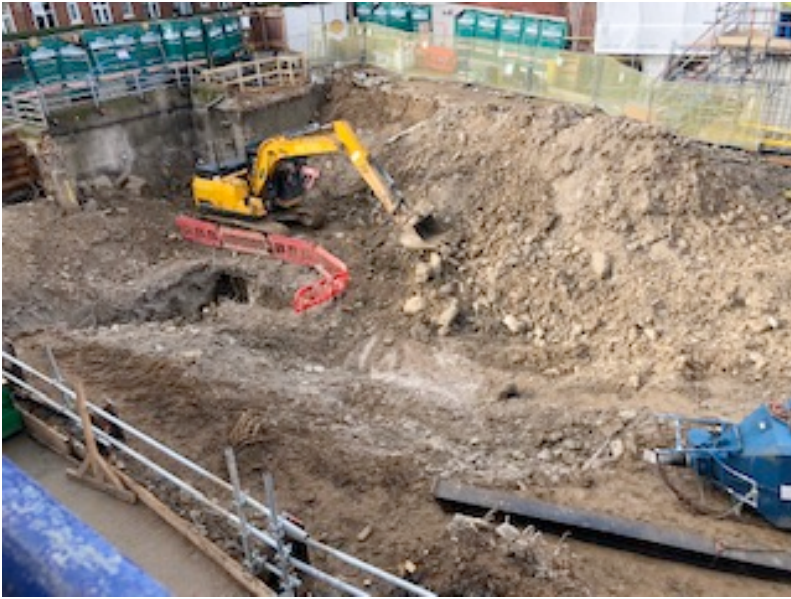
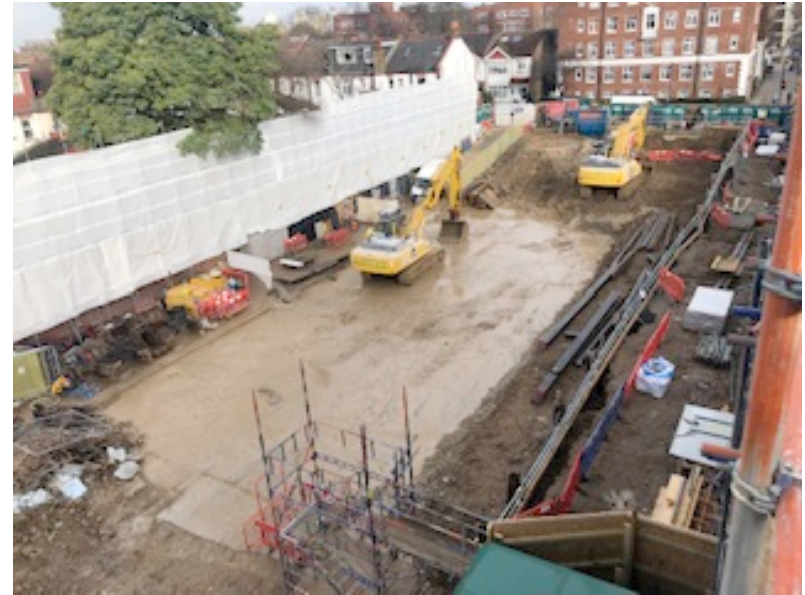
CEMP Item	Observation	Recommendations	Implementation Time
<p><b>1. Noise Management</b></p>	<p>At the time of the visit there were three excavators on site.</p> <p>All excavators had bucket attachments, and were moving earth created from the 'jack hammering' that had been done earlier on in the day.</p> <p>Noise levels were audible at the site boundary, however this would be masked by road traffic noise from Brixton Hill (A23) periodically.</p> <p>Noise levels at the time of the visit were satisfactory.</p> <p>Real time noise / vibration monitoring is being undertaken at two locations adjacent to Sudbourne Road and Hayter Road.</p>	<p>No Recommendations at time of visit</p>	<p>N/A</p>
<p><b>2. Air Quality Management (inc Dust)</b></p>	<p>The ground surface was generally damp due to rainfall and ground water.</p> <p>Aggregate movement and demolition of the basement floor are the main sources of dust production, this has been suitably suppressed.</p>	<p>No Recommendations at time of visit</p>	<p>N/A</p>

Localized breaking and earth moving
