# CEMP Inspection

Site inspections were undertaken of the former Olive Morris House on Brixton Hill Road on Monday 5 October and Thursday 8 October 2020, to establish compliance with the Construction Environmental Management Plan (CEMP)

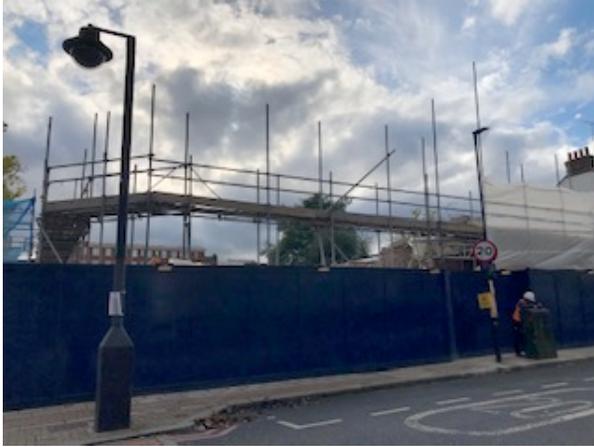
View from Sudbourne Road scaffolding partially removed

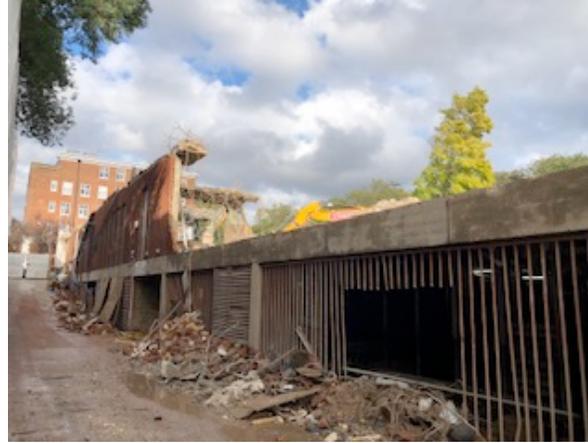
Site access road relatively clear

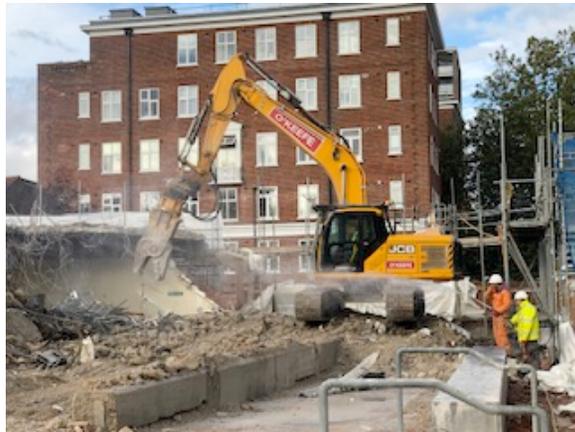
Last part of the building being demolished and water being sprayed

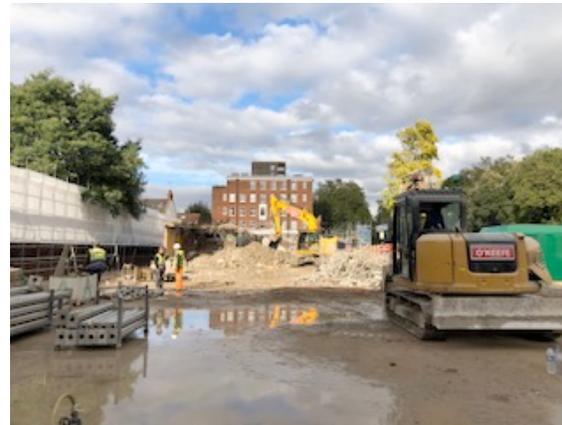
Site generally well managed and organised
