CEMP Inspection

A site inspection was undertaken of the former Olive Morris House on Brixton Hill Road on **Tuesday 9 February 2021**, to establish compliance with the Construction Environmental Management Plan (CEMP)

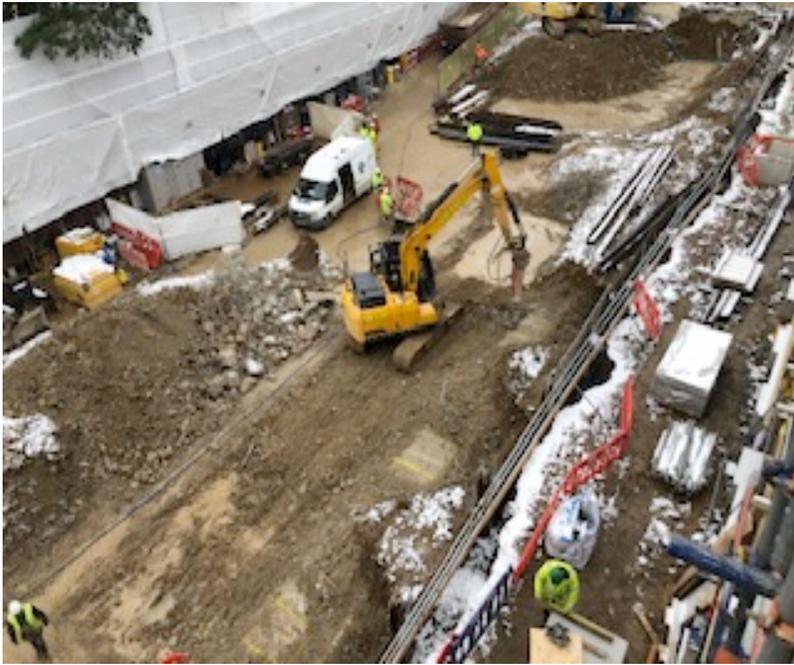
Localized breaking and earth moving

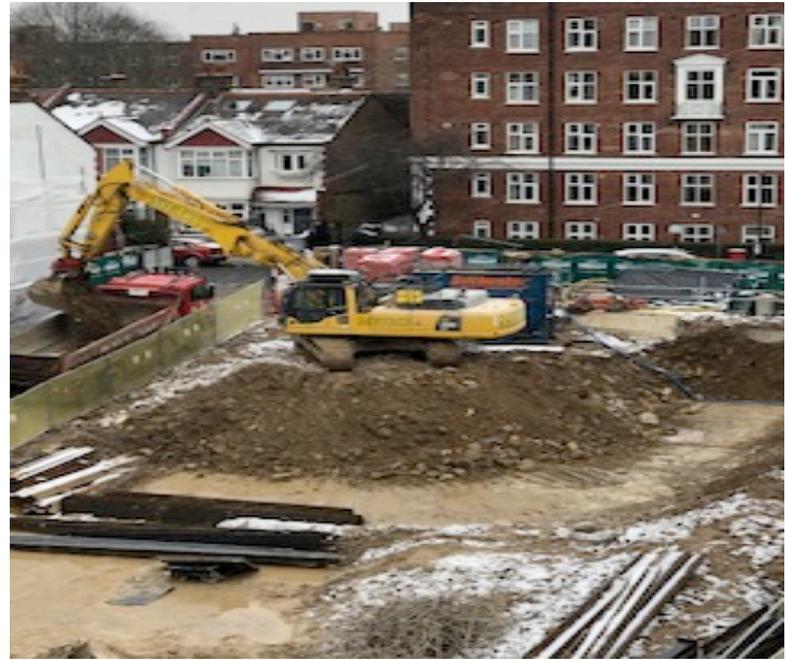
' Muck Away using a Tipper Truck
