CEMP Inspection

A site inspection was undertaken of the former Olive Morris House on Brixton Hill Road on **Wednesday 11 November 2020**, to establish compliance with the Construction Environmental Management Plan (CEMP)

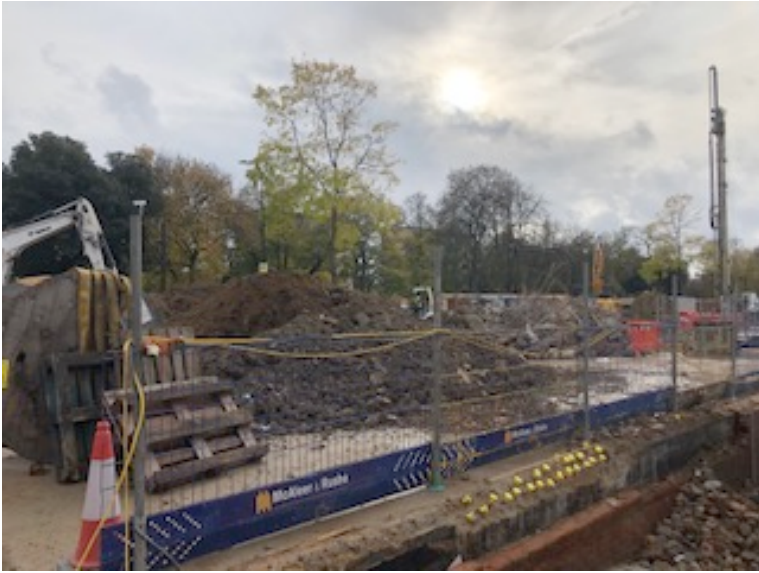
Excavator on site moving materials

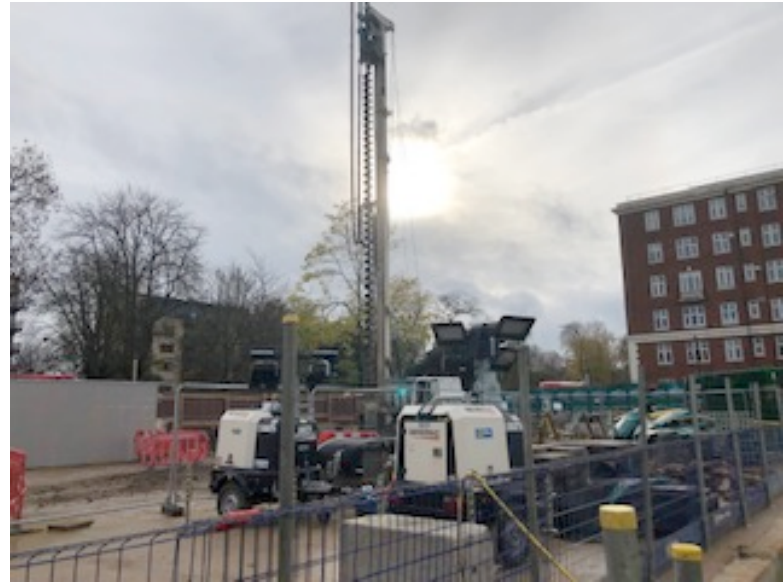
Auger Piling

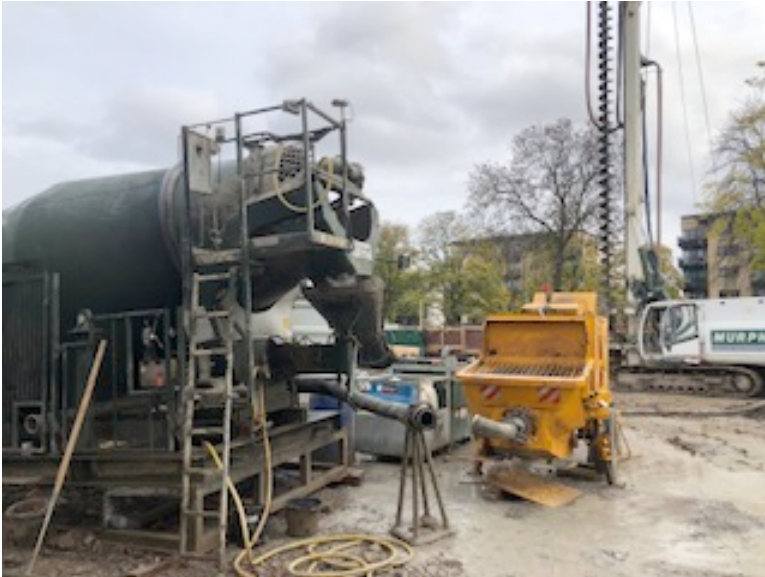
Site Batch Mixer
