# CEMP Inspection

A site inspection was undertaken of the former Olive Morris House on Brixton Hill Road on **Friday 22 January 2021**, to establish compliance with the Construction Environmental Management Plan (CEMP)

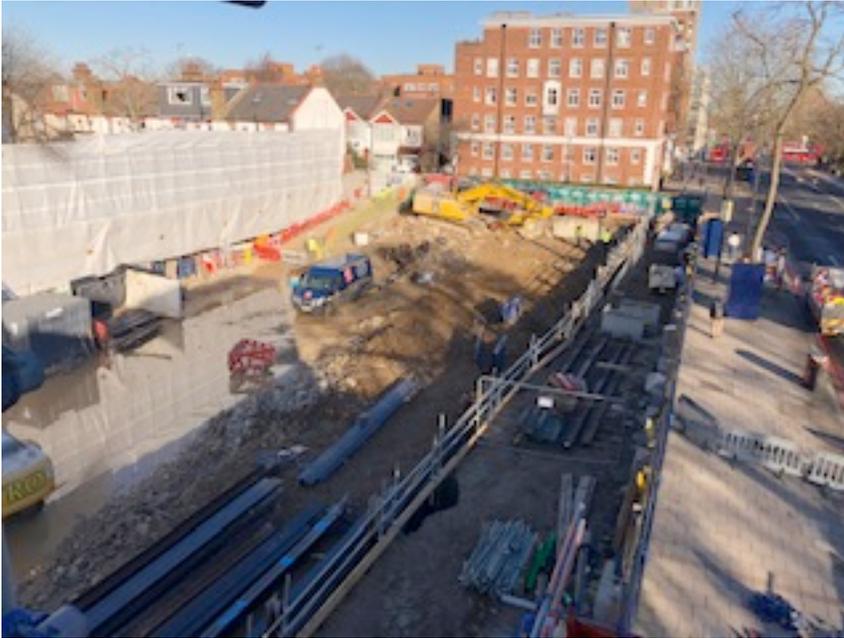
Ground work at Sudbourne Road end

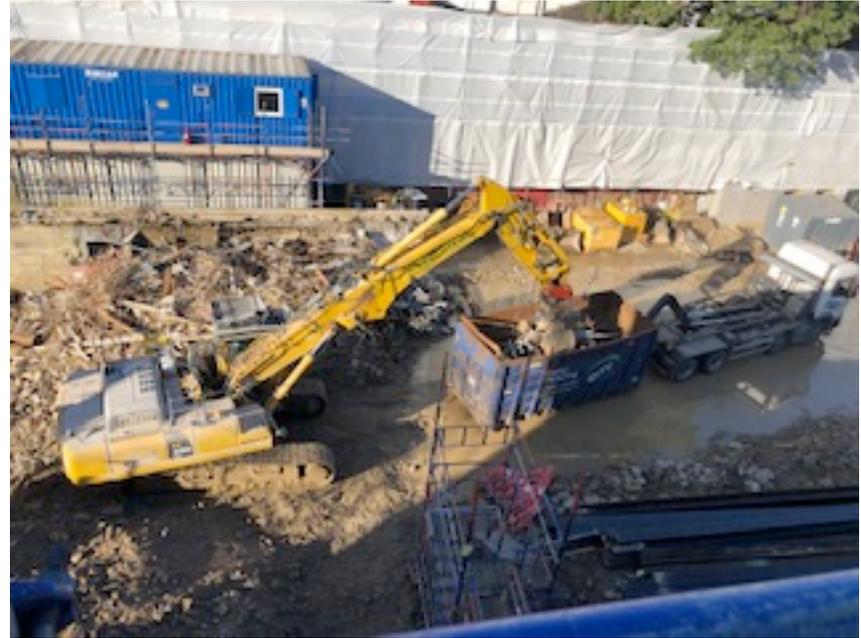
Excavator loading waste metal into skip
