CEMP Inspection

Site inspections were undertaken of the former Olive Morris House on Brixton Hill Road on Wednesday 21 October and Friday 23 October 2020, to establish compliance with the Construction Environmental Management Plan (CEMP)

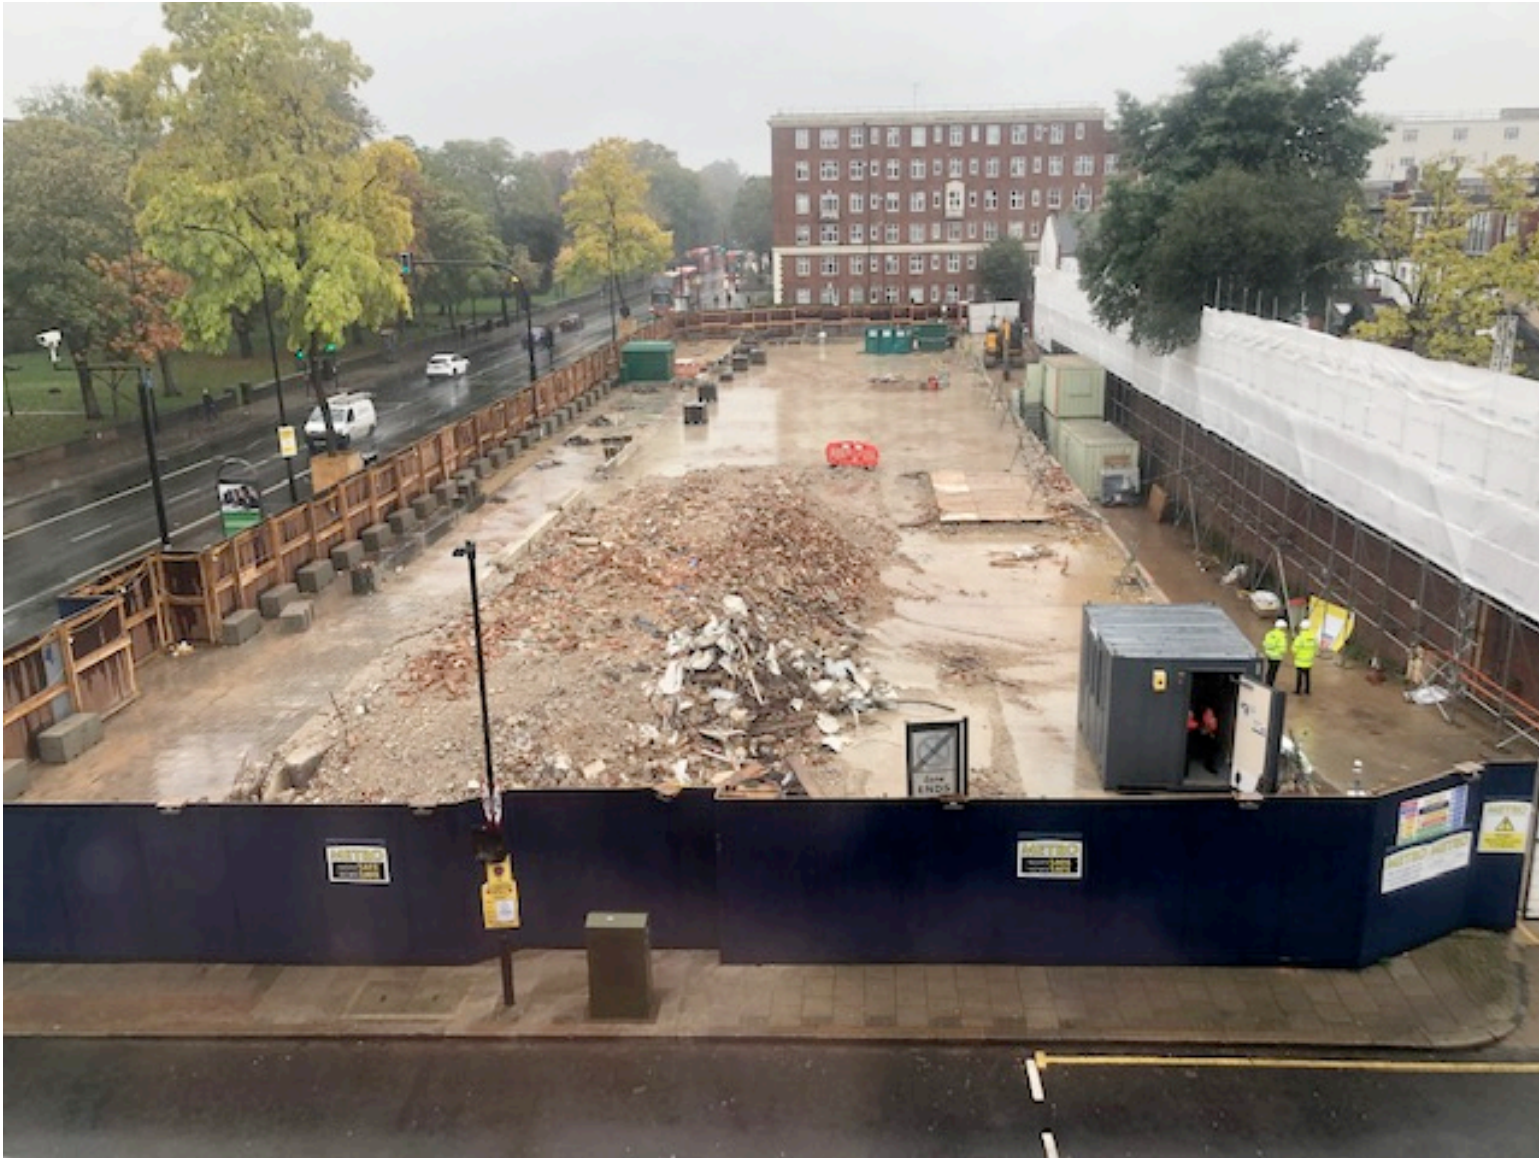
Arial view of the site, minimal construction
