CEMP Inspection

A site inspection was undertaken of the former Olive Morris House on Brixton Hill Road on **Friday 29 January 2021**, to establish compliance with the Construction Environmental Management Plan (CEMP)

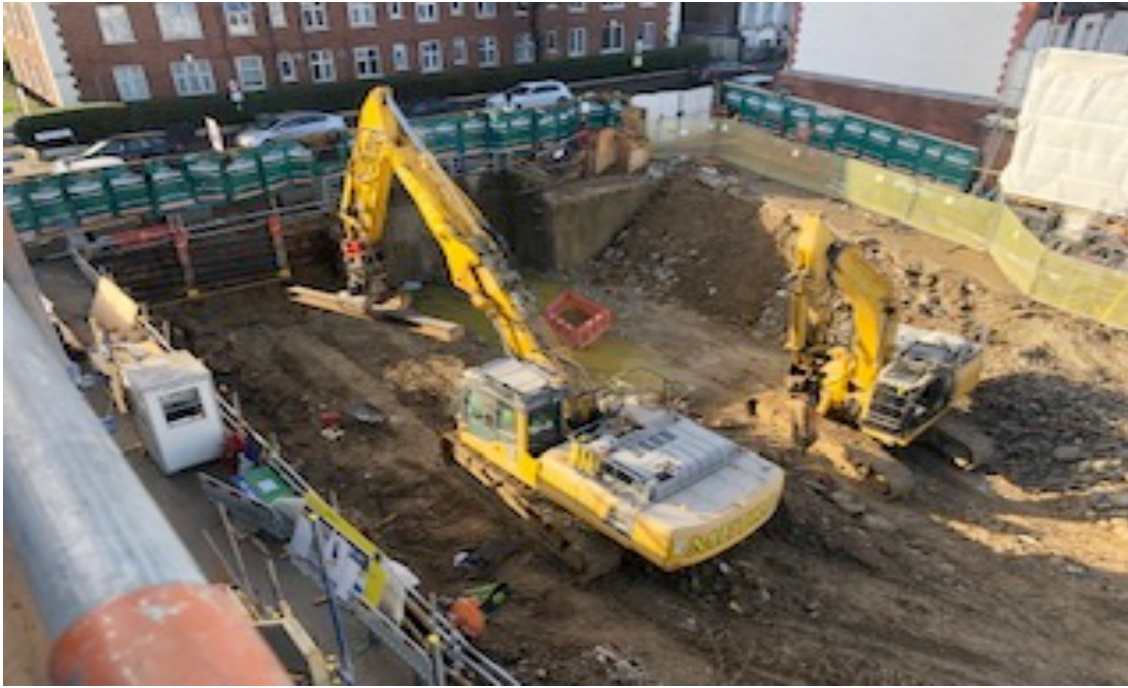
Photo

Shoring up of the basement using the excavator
