# CEMP Inspection

A site inspection was undertaken of the former Olive Morris House on Brixton Hill Road on Monday 26 October 2020, to establish compliance with the Construction Environmental Management Plan (CEMP)

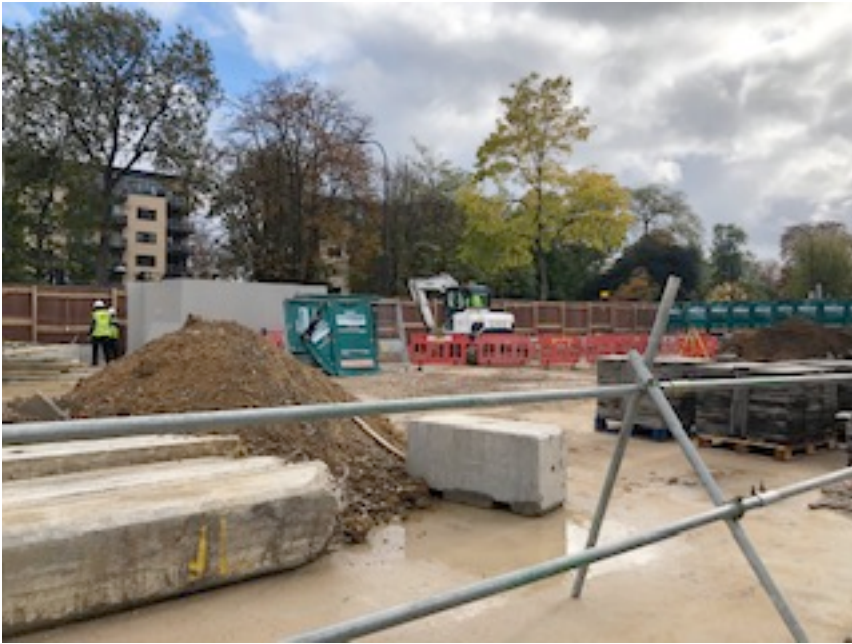
Excavation and Pile Probing Works

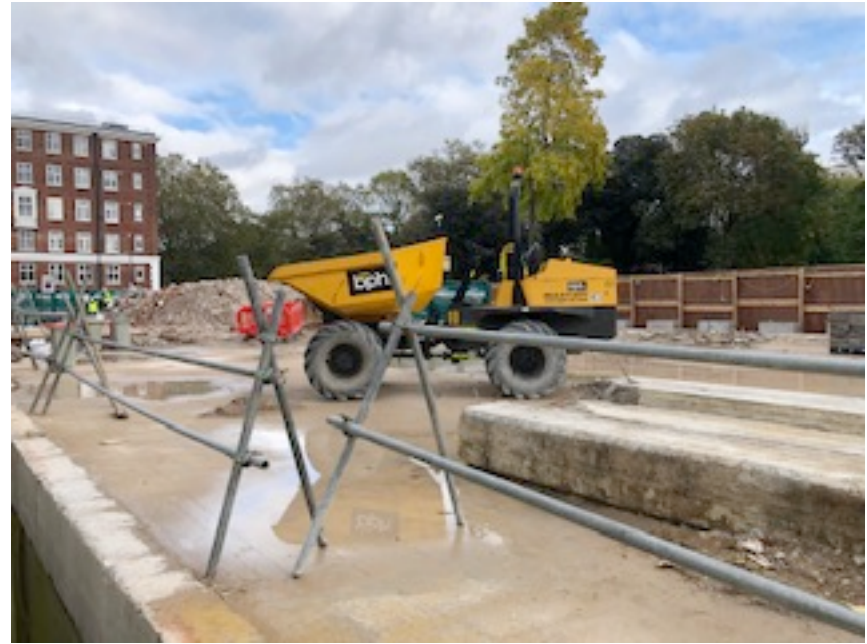
Minimum site traffic and movement
